TECHNICAL BASES FOR THE DEVELOPMENT OF A TEST STANDARD FOR IMPACTS OF POWERED TWO-WHEELERS ON ROADSIDE BARRIERS

Paper Number 07-0332

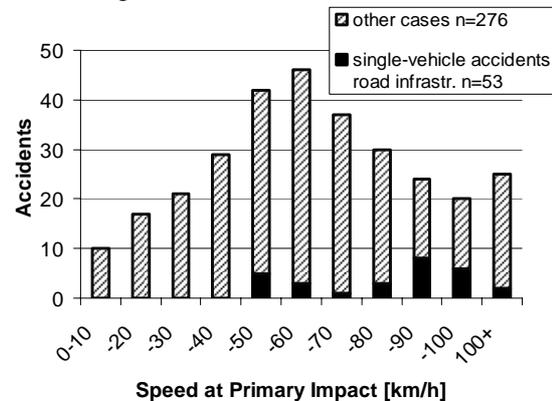
Figure 1. Impact speed for accidents involving impacts to road infrastructure compared to all other cases (DEKRA data).

The median primary impact speed for accidents involving impacts to road infrastructure was above 50km/h for all the four databases. Figure 1 and 2 give the distribution of impact speeds for the DEKRA data and the GIDAS data, respectively. These figures show the quite different overall distribution of impact speeds between the two databases. The numbers of relevant cases within the COST data and the Dutch MAIDS data were small with 16 and 4, respectively.

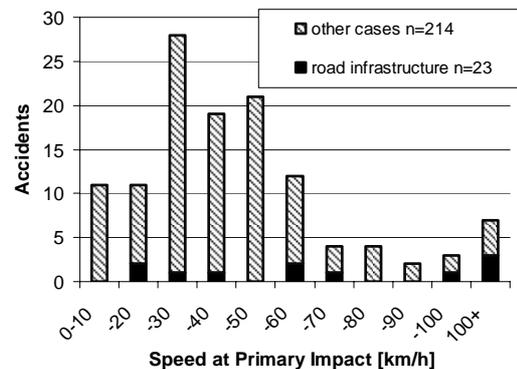
Figure 2. Impact speed for accidents involving impacts to road infrastructure compared to all other cases (GIDAS 2002 data).

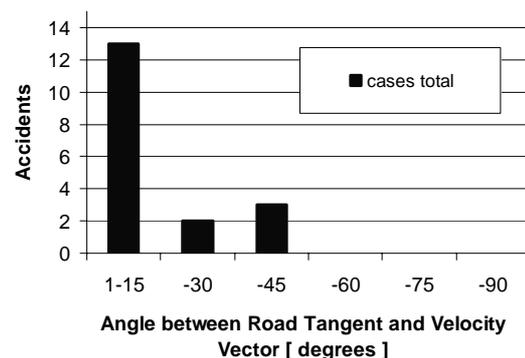
Figure 3. Road leaving angle (GIDAS 2002 data).

Only the GIDAS data contained information on the road-leaving angle, i.e. the angle between the velocity vector of the powered two-wheeler and the road tangent. In case a roadside barrier was installed next to the road, this angle would be

approximately the impact angle. Figure 3 shows the distribution within different angle ranges. This supports the observations found in the literature, that impacts to roadside barriers usually involve shallow angles.

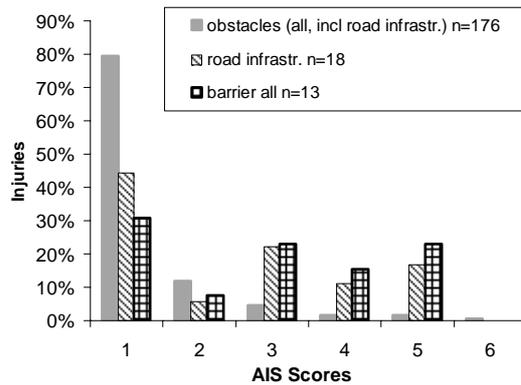
Figure 4. Severity of injuries caused by different groups of obstacles (GIDAS 2002 data).

The GIDAS and the COST data allowed an analysis of injuries and the objects that had caused them. Figure 4 shows the severity of injuries caused by impacts to different groups of obstacles. Injuries caused by obstacles in general were predominantly of AIS1 score. However, looking at injuries caused

by road infrastructure or barriers, a shift towards higher AIS scores can be observed.

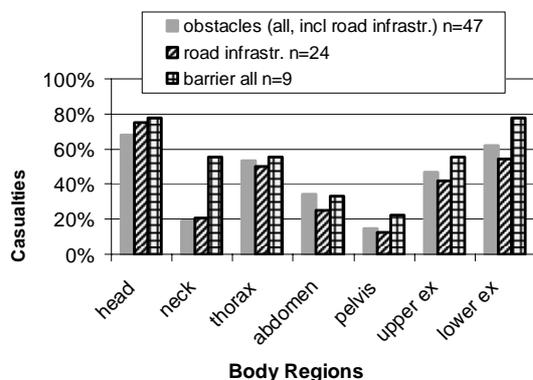
Figure 5. Location of injuries caused by different groups of obstacles (COST 327 data).

Figure 5 gives the location of the injuries that were caused by impacts to obstacles in general, road infrastructure and roadside barriers. The most commonly injured body regions are the head and the lower extremities, followed by the thorax and the upper extremities. There was a high incidence of neck injuries caused by barrier impacts. The number of cases is small however, and this result could also be related to the inclusion criteria of the COST database.

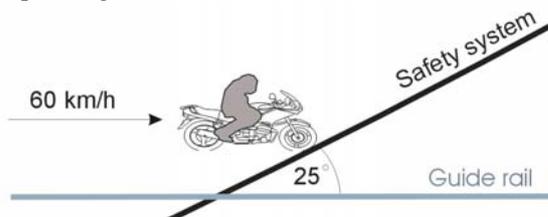
Figure 6. Parameters inclined impact.

The first of the two impact configurations is depicted in figure 6. The initial velocity of the motorcycle leaving the sledge was 60 km/h and the impact angle was 25°.

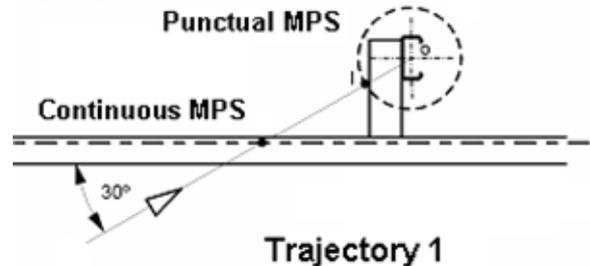
Figure 12. Trajectory 1.

- Trajectory 1 – Centred post impact: Applicable to punctual and continuous MPS with an approaching angle equal to 30°, as the Figure 12 shows.

The main objective of the roadside barriers is to redirect the motorcyclist into the road but very close to the barrier. The roadside barriers should have the appropriate stiffness to achieve this objective. A very high stiffness barrier can cause serious injuries of an impacting motorcyclist. On the other hand, a very compliant barrier could absorb a lot of energy but also allow the rider to override the upper rail of the system. To assess this issue, a rail-centred impact has to be performed (figure 14). A very compliant lower rail can also lead to a severe contact of the motorcyclist with the post in trajectory 1 (figure 12), which is actually to be prevented by the MPS.

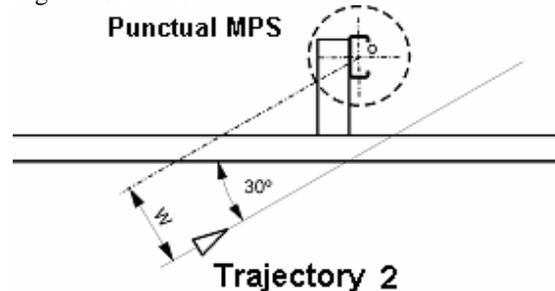
Figure 13. Trajectory 2.

- Trajectory 2: Excentric post impact: Applicable only to punctual MPS. It is the horizontal line that goes at a distance ‘W’ of the center of masses of the post, with an approaching angle equal to 30°, as the Figure 13 shows.

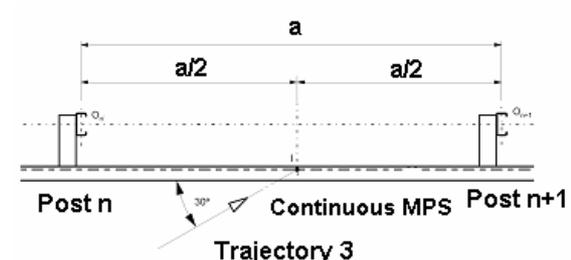
Figure 14. Trajectory 3

- Trajectory 3: Centred rail impact: Applicable only to continuous MPS (figure 14).

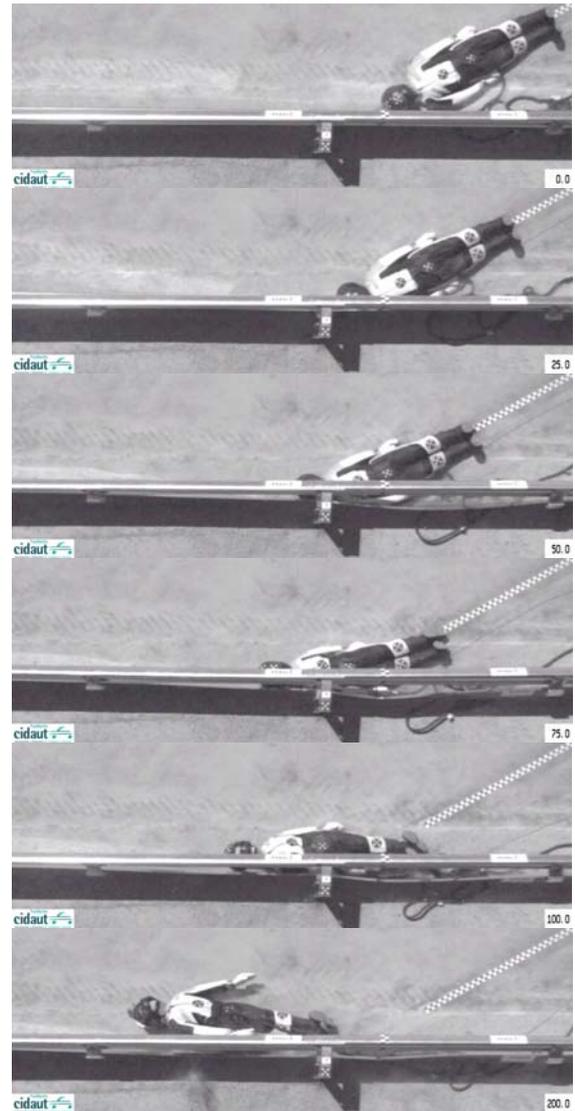
Figure 17. Test top view.

By courtesy of HIASA, an example of an impact test passed with level I result (best level) according to the Spanish standard is shown in figures 16 and 17.

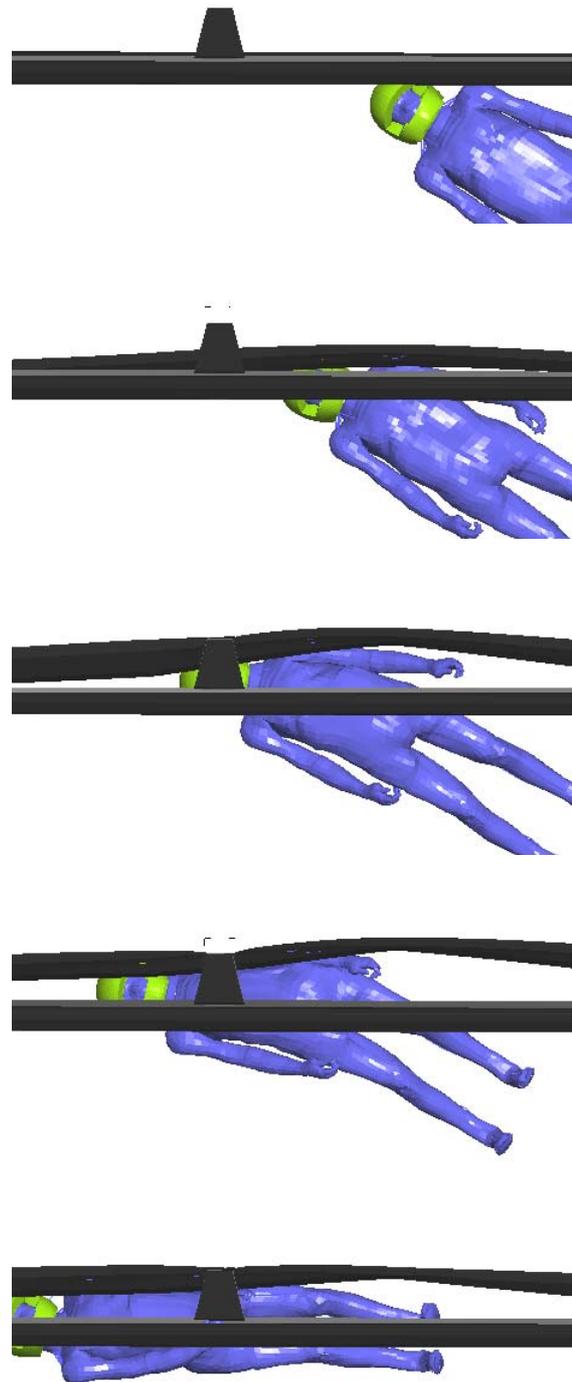
Figure 18. Impact simulation with human model (steps of 25ms).

Simulation with Human Model – The PAMCrash HUMOS2 model has been validated for lateral thorax loading [Merten 2006] and it has been demonstrated to depict injury mechanisms in motorcyclists' impacts to roadside barriers [Peldschus & Schuller 2006]. The sequence of the simulation given in figure 18 shows an impact as in the test of figure 17 with a similar barrier model provided by HIASA. In this simulation the deflections of the impacted half of the thorax were measured according to the methodology presented in [Kuppa et al. 2003]. The maximum deflections at 50% of the half circumference of the thorax at the height of rib 4 and rib 8 were 51mm and 48mm, respectively. These results indicate a risk for severe thoracical injuries caused by lateral loading in such an impact. It is therefore suggested to include injury criteria for lateral thorax loading in a test procedure of sliding barrier impact.

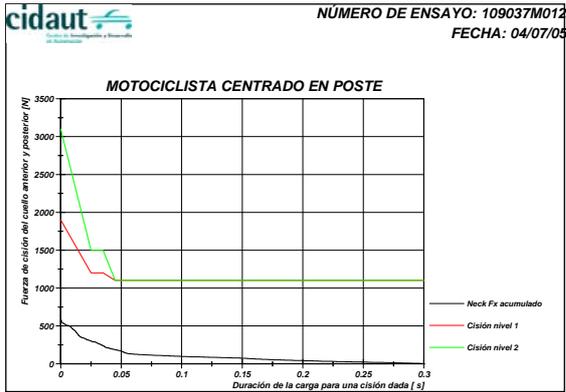
Appendix A Fx measured on neck

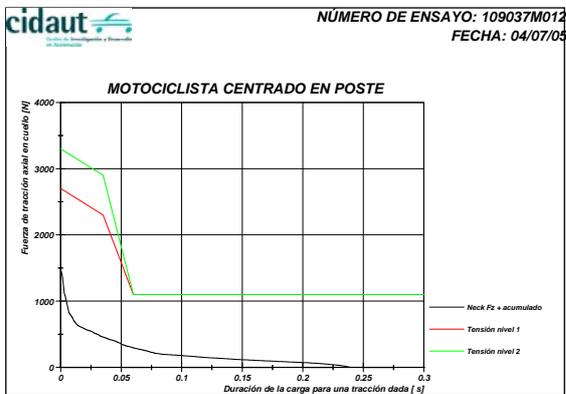
Appendix B Fz traction measured on neck
